# Manhole Inspection Summary

Manhole # S45G\_\_012MH

Insp Date: **7/15/08 2:14 PM**

**Location** Address: **s washington st**

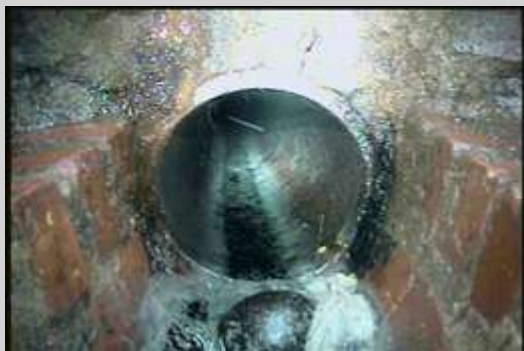
3 O'Clock Inflow

8 in. Circular Gravity Sewer  
Pipe In @ 9 O'Clock

Deposits: ☒ **None** ☐ Mud ☐ Sludge ☐ Debris ☐ Grease

Infiltration: **None** Pipe Seal Cond: **Unknown**

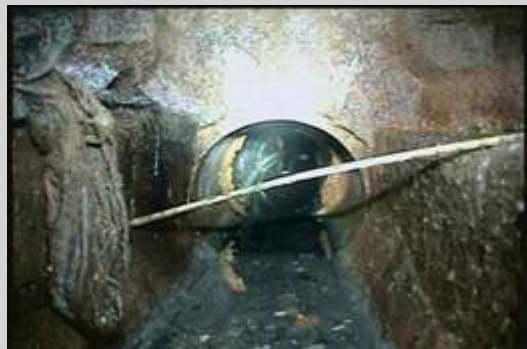
6 O'Clock Inflow

8 in. Circular Gravity Sewer  
Pipe In @ 6 O'Clock

Infiltration: **None** Pipe Seal Cond: **Unknown**
